## Building An Ultrasonic System to Pinpoint Arcing RFI Sources

Project and Article by KK4ICE - Dan Gunter January 6, 2015

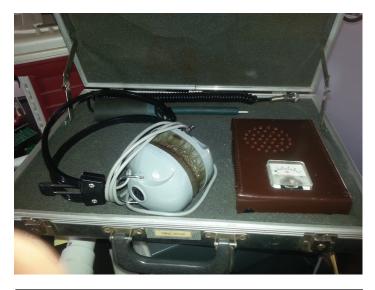
Fig. 2: The ultrasonic detection kit which was purchased as the foundation of my arcing RFI location system.

I purchased a used ultrasonic detection kit (Fig. 2.) The kit contained an ultrasonic amplifier/detector with a meter and speaker, a set of noise canceling headphones, a contact probe, and a sound concentrator. The original hand-held probe -- which did not require direct physical contact) was missing from the kit. That was not a problem, as I already knew I would be ordering some additional transducers to build a few additional sensors, one of which would be highly directional if all went as planned.

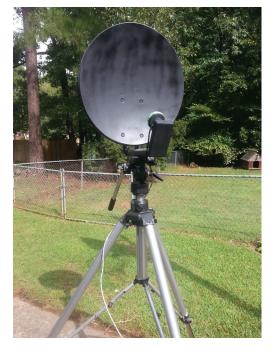
Fig. 5: Completed directional ultrasonic reflector, with a couple of coats of black paint applied.

and capable of picking up the ultrasonic sound from lightly rubbing your fingers together from a distance of 20' to 30'. Then I recruited the same ham radio buddy to stand about 50' away from the reflector/transducer assembly and squeeze an empty nasal spray bottle which was taped to the top of a camera tripod in order to keep its location stationary. Doing so produces low volume ultrasonic sound as well as the audible "hiss" our ears can normally hear. This allowed me to aim the dish/reflector for maximum meter reading with the ultrasonic amplifier/converter. It is somewhat fascinating that you can stand right in front of this dish with the ultrasonic detector and shout into it without the ultrasonic amplifier/converter picking up anything. But rub your fingers together even lightly in front of it and you will quickly discover if you have the volume on the amplifier turned up higher than you realized.

Once this was done, I located a couple of points on the repurposed satellite dish and LNB to use as a "sight" of sorts. Moving the dish around and then aiming it using the sighting points yielded maximum level and confirmed that it was indeed

very directional -- aiming two to three inches to either side or above or below the ultrasonic sound source dropped the meter reading considerably or made it drop off to nothing.
